CHAPTER SEVEN

CIRCULATION AND ACCESS

Circulation and access help Oakland continue to thrive as a public space. This chapter addresses vehicular circulation, pedestrian circulation, and amenities that support improved access.

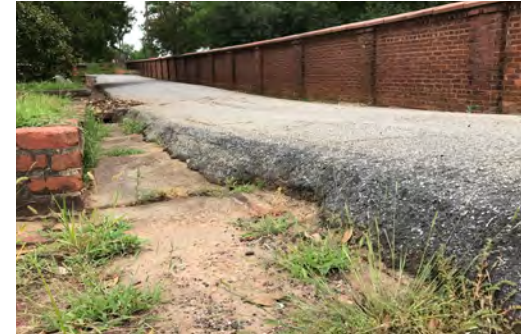
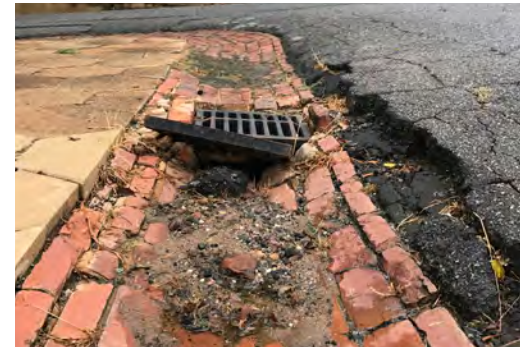
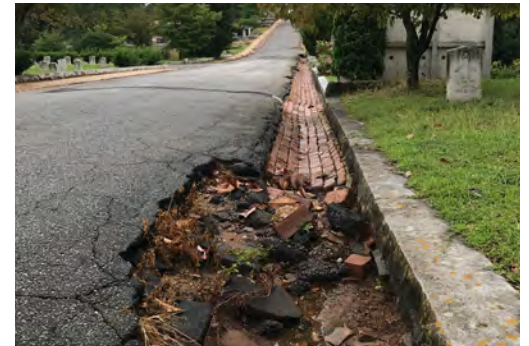
Top: Layers of asphalt rise above original brick gutters. Middle: Standing water leaves sediment at a broken inlet. Bottom: Failing asphalt road and gutter is no longer functional.

Currently, asphalt pavement on roads throughout Oakland is in poor condition and in many areas has been repaved without removing earlier layers, which has caused the road to rise even further above original brick gutters. This creates unsafe and unpredictable transitions from road to walkway, impedes accessibility for those with disabilities, and results in a steep cross slope which causes drainage problems.

The original brick gutters which follow the roadways have held up well over time though many require repair. Voids in mortar joints allow water to get under brick and decrease the gutter function. Blocked and clogged inlets have similarly allowed sediment to fill and even turf to grow over gutters, leaving large areas of standing water. Many grates also fail to serve their purpose because they are elevated above the road.

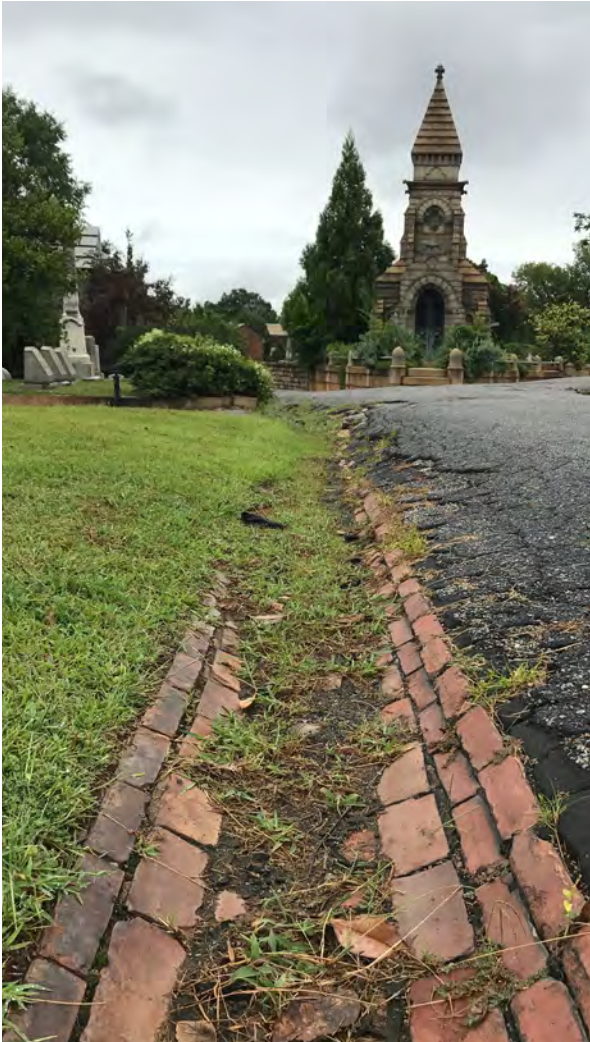
Some brick gutters have lost functionality over time due to sediment and vegetation

- Repair brick gutters and sub-base – This will require resetting the sub-base, re-pointing, and in some places revealing gutters where sediment or vegetation has grown over them. (See page 87.)

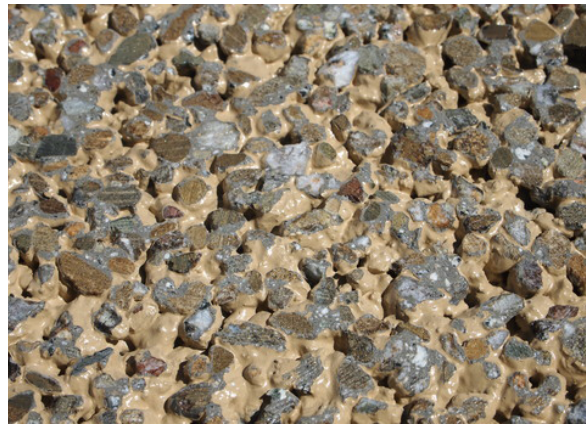
Larger aggregate size of pervious concrete pavement, with integral color

- Oakland's roads require full-depth pavement replacement. The Pavement Replacement map depicts a two-phased pavement replacement which recommends the use of permeable concrete unit pavers in specific locations with the remaining roadway constructed of porous, integrally colored concrete. The tan-colored chert and limestone screenings used to pave Oakland's roads in the past were desirable

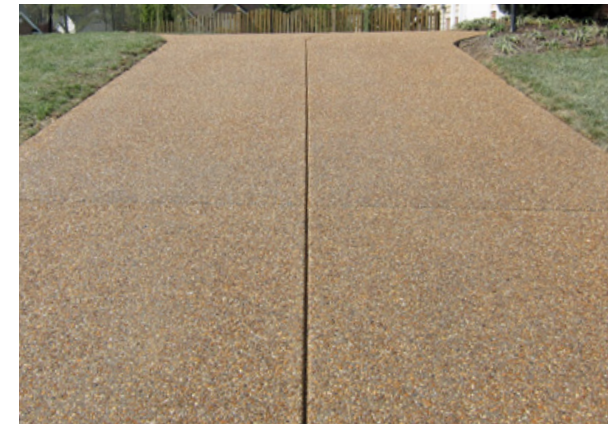
An example of a pervious concrete path with integral color

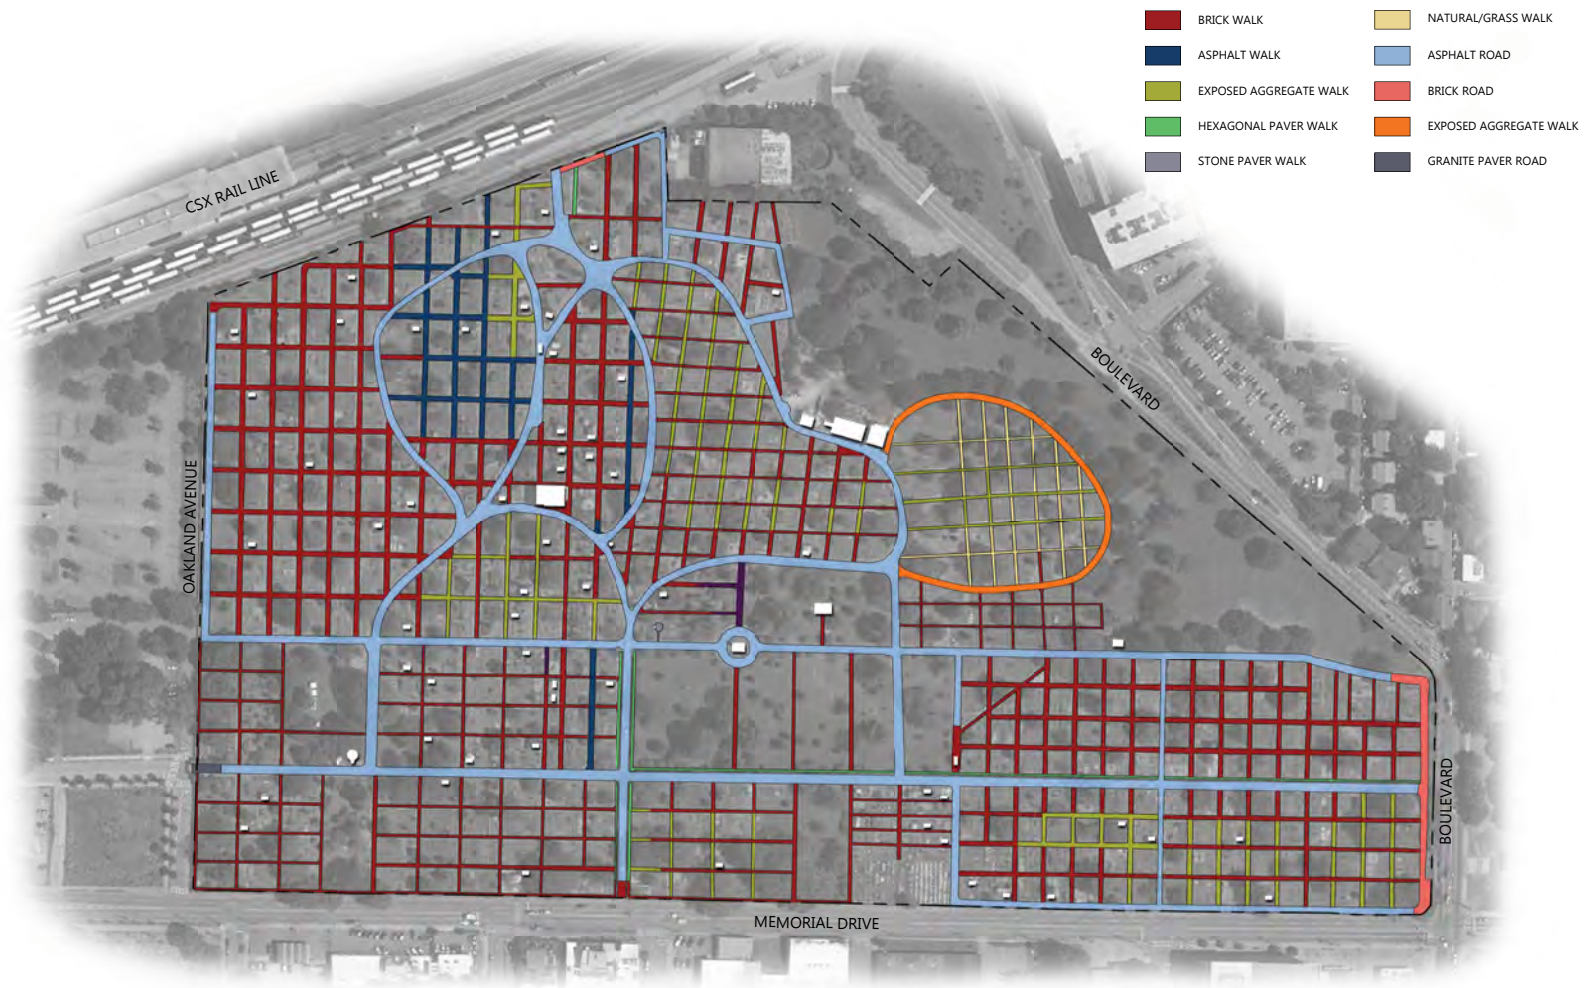
PAVEMENT MATERIALS

Existing pavement conditions depict the variety of pavement conditions, and need for full depth replacement on all roads.

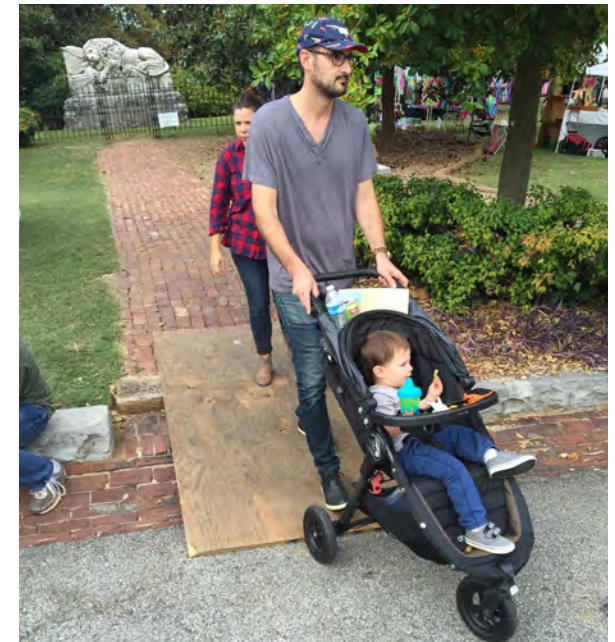
Improvised accessibility solutions used for events and tours.

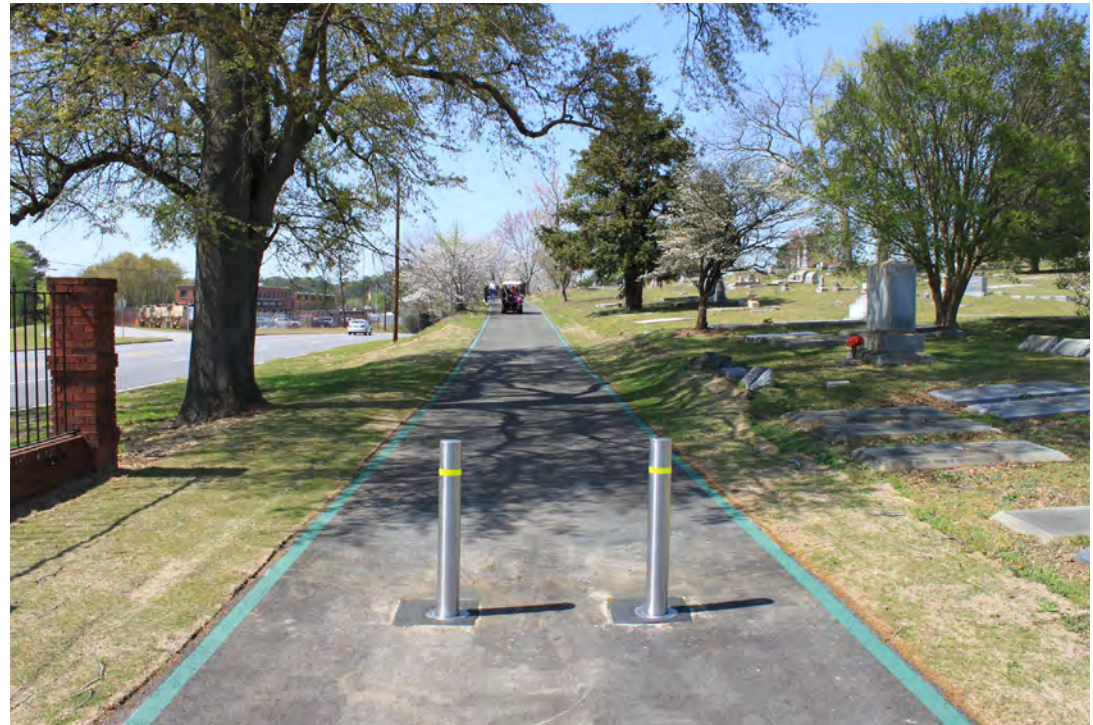
An example of removable bollards incorporated at Riverside Cemetery in Macon, Georgia.

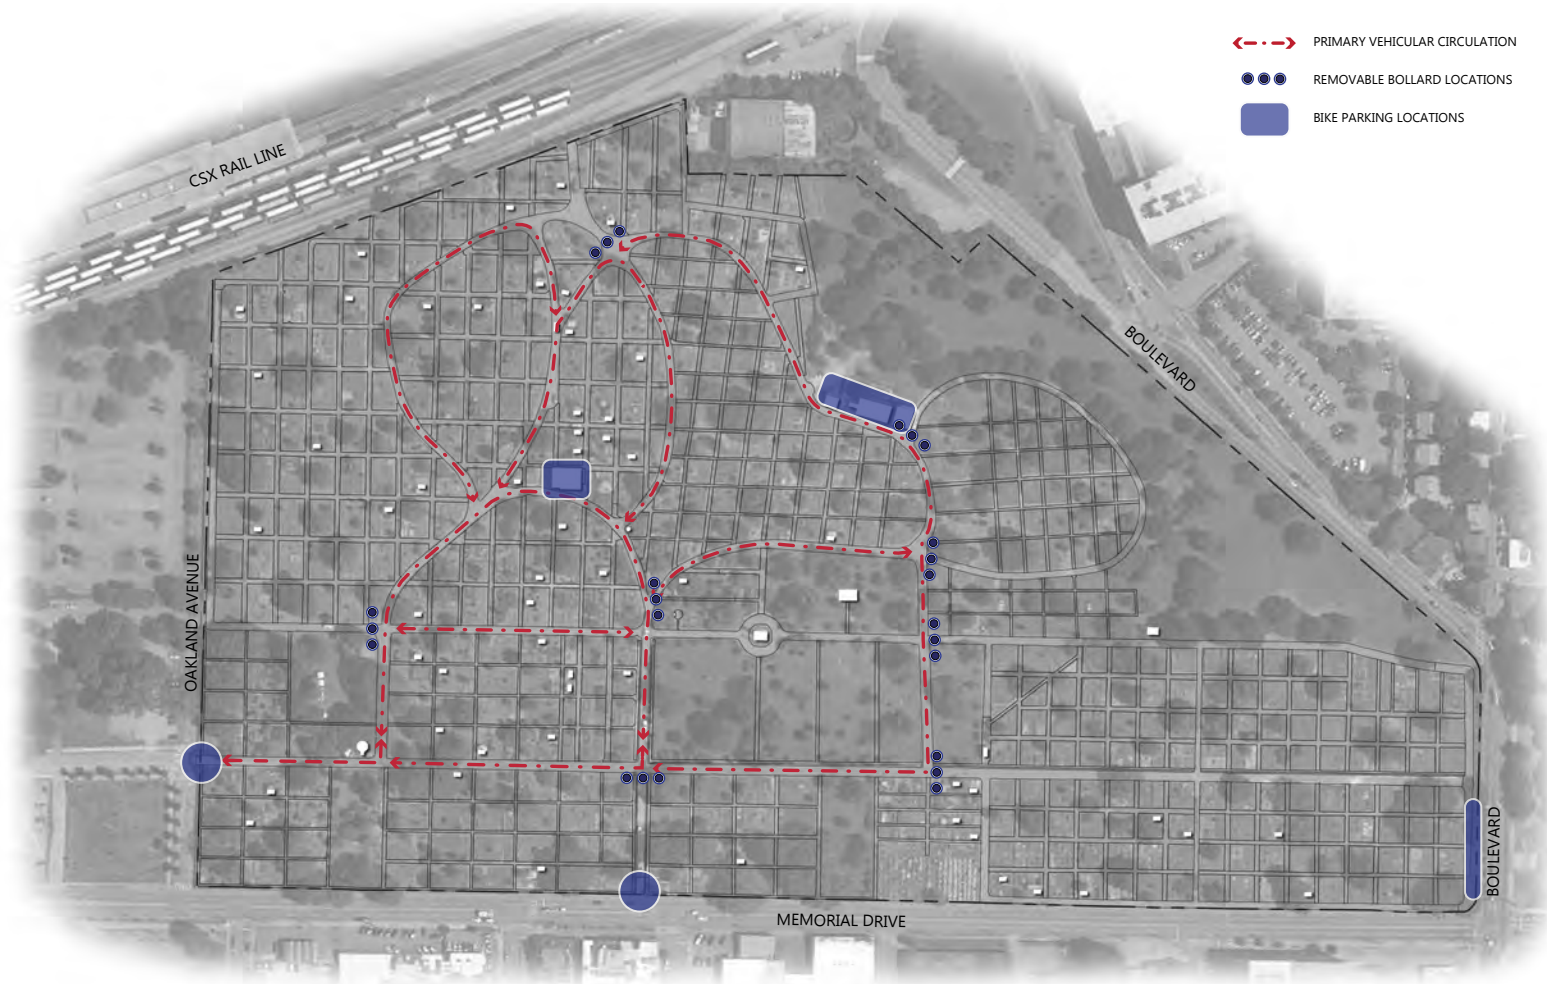
REMOVABLE BOLLARDS AND BIKE PARKING

Bike parking should be near most used areas. Removable bollard locations restrict and simplify vehicle circulation. Seating options should be added as needed in the northern and eastern portions of Oakland. These areas are most park-like and seating will encourage visitation.

Three strategies address bicycle racks, removable bollards, and seating to work in conjunction with other strategies to improve the visitor experience throughout Oakland. Refer to the Removable Bollards and Bike Parking map on the following page showing locations for each.
